Kenwood TS-830

Survival Guide

Kenwood TS-830 Survival Guide, ed. [Olaf Rettkowski](#), DL9AI, ver.1.2, 03 Dec 2002,
rev. 21 Dec 2008

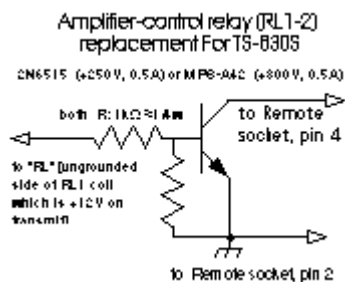
6.1 Excessive delay in relay control signal to external amplifier--which causes hot switching in the amplifier's RF relays

Cause: The RF relay in the TS-830S also switches the external amplifier relay control line. Thus, the amplifier relays can not begin to close until the RF-relay in the TS-830S has closed.

Fix: Install a NPN >200V switch transistor [MPS-A42 or=] in the TS-830S to take over the job of relay control line switching. The input [base] of the switch transistor is driven by the +12V on transmit signal ["RL"] that drives the coil of the TS-830S' RF-relay, RL1. The base-current is limited to approx. 11 mA with a 1 KOhm series resistor. Connect another 1 KOhm resistor between the emitter and the base to drain off the stored charge in the base. The emitter connects to chassis-ground. The collector connects to the wire from pin 4 on the Remote socket. Pin 2 of the remote socket should be connected to chassis-ground or to the emitter of the transistor. The NPN transistor can only switch a positive relay-control line voltage, so this circuit will not work on negative relay-control voltage amplifiers like the SB-200 and the 30L-1. The fix is to convert these amplifiers to [standard] positive V relay control line polarity. A solid-state electronic cathode bias switch [ECBS] is useful in this application. Such a circuit is shown in QST magazine, January 1994, "The Nearly Perfect Amplifier."

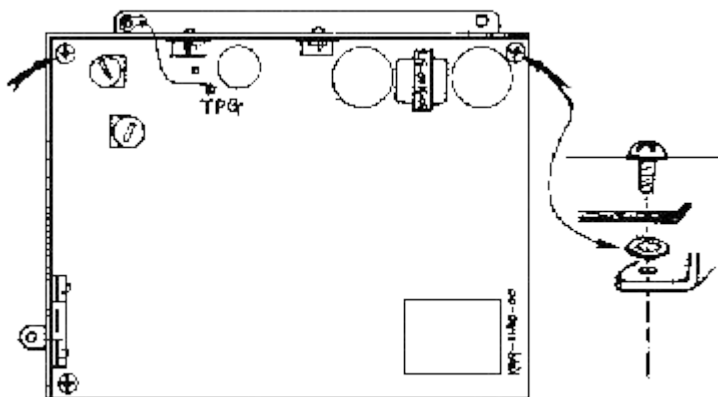
Some users may report an intermittent shift in the display and operating frequency. This may typically be a 1 to 4 KHz random shift. Cause will be a loose grounding screw on the AF/AVR unit heat sink.

1. Remove the top cover (8 screws) and unplug the speaker.
2. Remove the bottom cover (8 screws).
3. Remove 5 screws holding the AF/AVR unit and swing the board over. Leads do not have to be unplugged.
4. Add two tooth-lock washer as shown.
5. Replace the circuit board and heat sink to the chassis, adding the solder lug as shown.
6. Solder a jumper between the TPG wrap post and the added solder lug.
7. Replace the top and bottom covers.

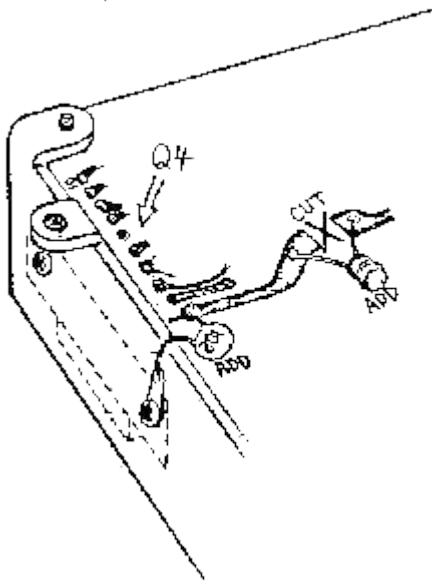
Transmitter "talkback", either with or without a linear amplifier, may be eliminated by adding a filter at the receiver audio power amplifier.

On the AF unit X49-1140-00 at Q4, cut the 12 V DC B+ line between R47 and C28, and add a 1 μ H choke (L40-1092-02) in-line. Add a 0.01 μ F cap (C52-1710-36) from the IC pin 1 to ground, as shown using a 3 mm lug (E23-0015-04) under the IC mounting screw on the heat Sink.
