## Studies of High Temperature Sliding Wear of Metallic Dissimilar Interfaces III: Incoloy MA956 versus Incoloy 800HT

Wear variations of Incoloy MA956 slid against Incoloy 800HT between room temperature and 750°C, and sliding speeds of 0.314, 0.654 and 0.905 m.s<sup>-1</sup> were investigated using a 'reciprocating-block-on-cylinder' (low debris retention) configuration.

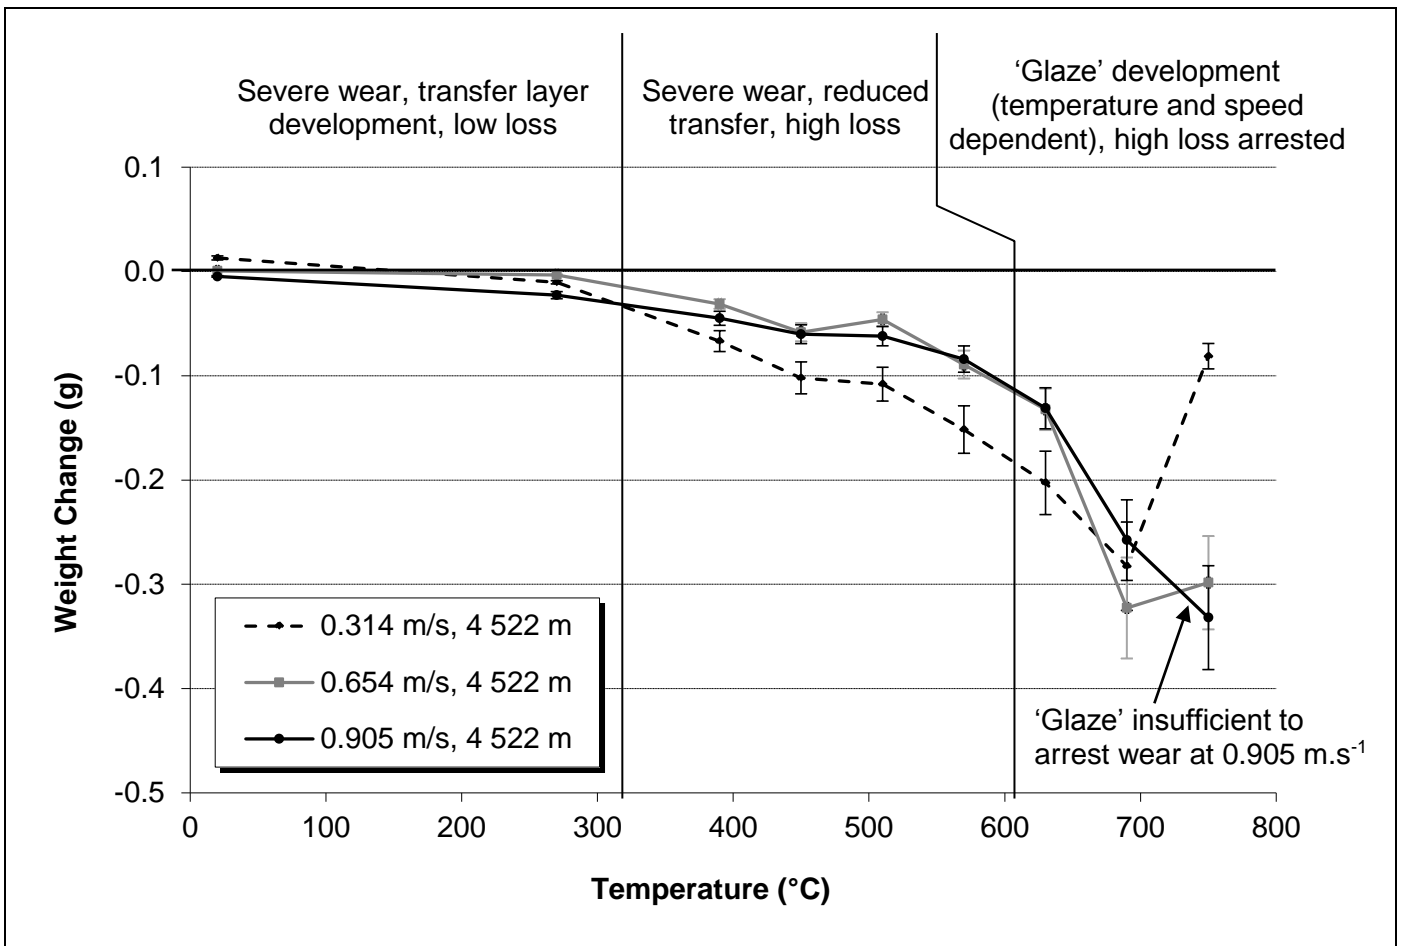
**Fig. 2:** Effect of temperature on weight change – Incoloy MA956 vs. Incoloy 800HT (load = 7N, sample size = 3)

At 0.314 m.s<sup>-1</sup>, weight change values (Fig. 2) indicated at first a gradual but later accelerating rise in Incoloy MA956 weight loss with increasing temperature (mean weight change -0.002(9) g at R.T., -0.151(6) g at 510°C), with large jumps in weight loss notably at 630°C (-0.202(7) g) and 690°C (-0.282(6) g). A decrease in weight loss was observed at 750°C (-0.090(3) g).

Observed wear behaviour at 0.654 m.s<sup>-1</sup> followed a very similar pattern to that at 0.314 m.s<sup>-1</sup> (Fig. 2). There was a gradual increase in weight loss between room temperature (negligible weight change) and 510°C (-0.0459(4) g), this accelerating up to 630°C (-0.132(2) g). There was a large jump in weight loss at 690°C (-0.322(7) g) followed by a limited decrease at 750°C (-0.298(4) g).

Between R.T. and  $630^\circ\text{C}$ , the pattern of wear behaviour at  $0.905 \text{ m.s}^{-1}$  followed a pattern similar to that at  $0.314$  and  $0.654 \text{ m.s}^{-1}$  (Fig. 2), with at first a gradual (mean weight change  $-0.004(7) \text{ g}$  at R.T.,  $-0.062(0) \text{ g}$  at  $510^\circ\text{C}$ ) but accelerating increase in weight loss ( $-0.131(2) \text{ g}$  at  $630^\circ\text{C}$ ). Additionally, lower weight change was observed at  $0.905 \text{ m.s}^{-1}$  than at  $0.314 \text{ m.s}^{-1}$  between  $390^\circ\text{C}$  and  $630^\circ\text{C}$ . However, weight loss continued to rise at  $0.905 \text{ m.s}^{-1}$  on increasing temperature to  $690^\circ\text{C}$  ( $-0.257(6) \text{ g}$ ) and (unlike  $0.314$  and  $0.654 \text{ m.s}^{-1}$ )  $750^\circ\text{C}$  ( $-0.332(0) \text{ g}$ ).

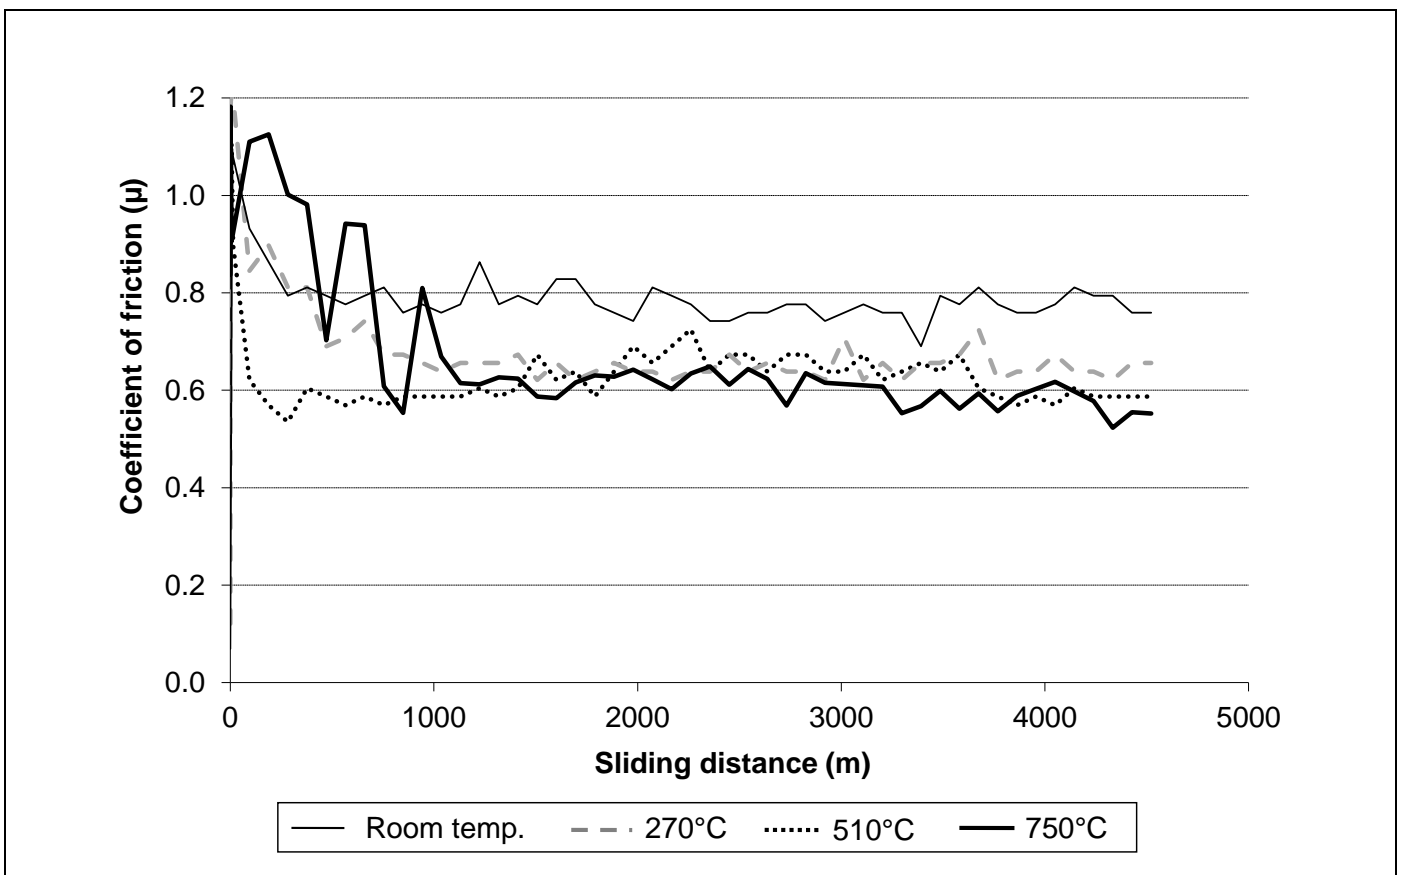
**Fig. 3:** Effect of temperature on friction at 0.314 m.s<sup>-1</sup> – Incoloy MA956 vs. Incoloy 800HT (load = 7N, sample size = 3)

Whilst there was no clear temperature-related trend in early peak 'run-in' coefficient of friction values (reaching to between 1 and 1.2 regardless of sliding speed – Fig. 3), a downward trend in 'steady state' values was observed, falling from between 0.75 - 0.85 at R.T., to 0.6 - 0.75 at 270°C, 0.58 - 0.67 at 450°C, 0.6 - 0.7 at 510°C and finally 0.4 - 0.6 between 630°C - 750°C.

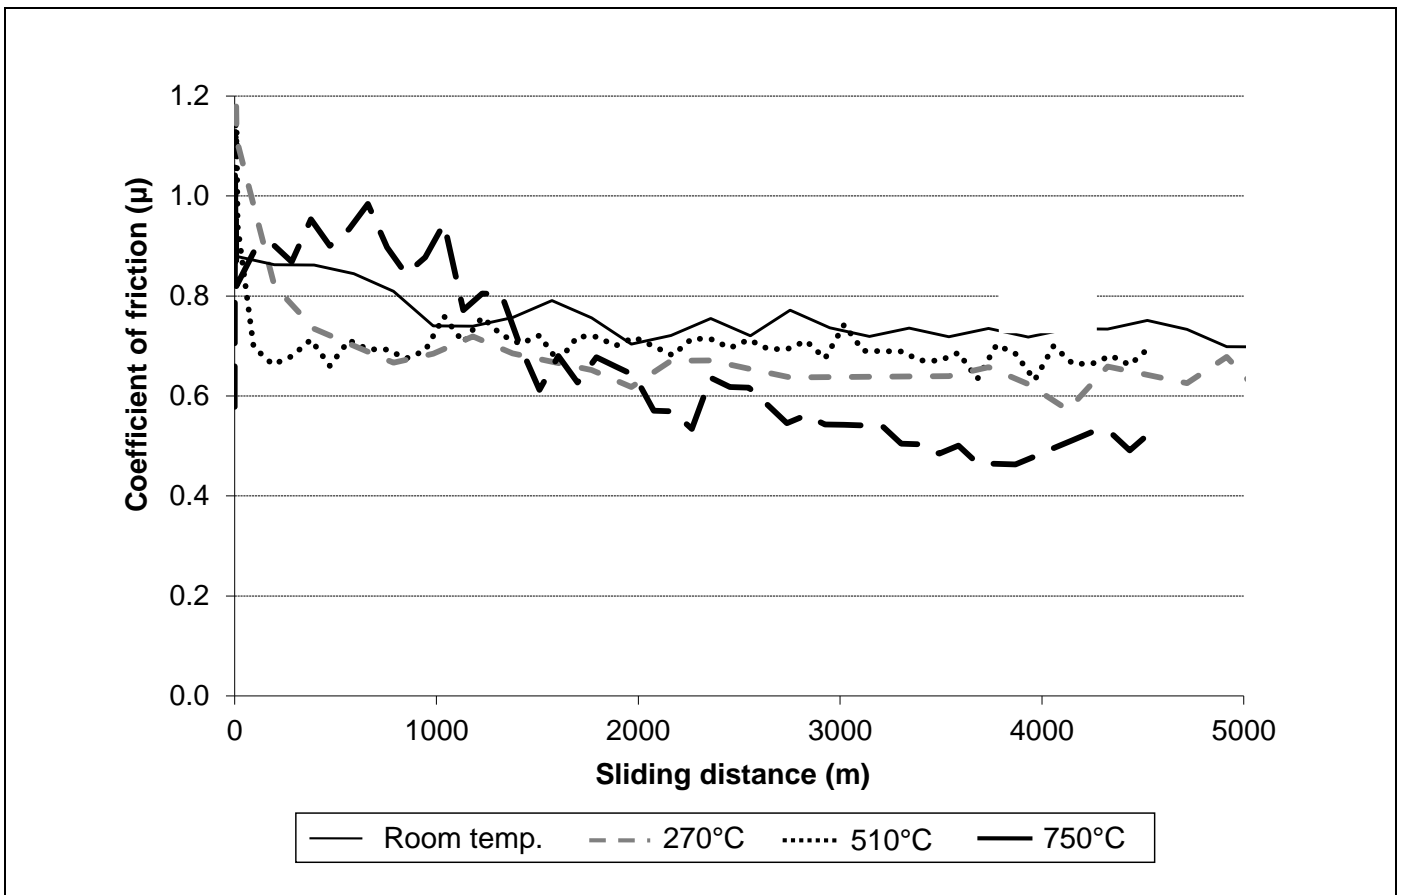
**Fig. 4:** Effect of temperature on friction at  $0.654 \text{ m.s}^{-1}$  – Incoloy MA956 vs. Incoloy 800HT (load = 7N, sample size = 3)

A change from more to less variable coefficient of friction from  $\sim 12\%$  to  $\sim 8\%$  coinciding with 'glaze' layer formation [2], was only observed at  $690^\circ\text{C}$  after  $\sim 1,908 \text{ m}$  and  $750^\circ\text{C}$  after  $\sim 1507 \text{ m}$ . No such change was observed at  $630^\circ\text{C}$ , suggesting the very limited oxidation was insufficient to eliminate 'metal-to-metal' contact before the end of testing.

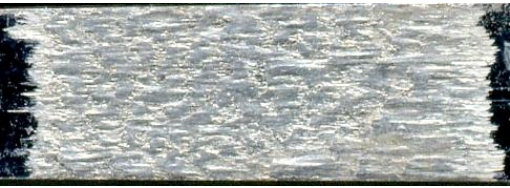
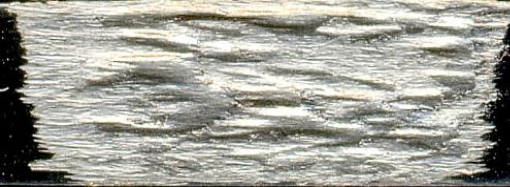
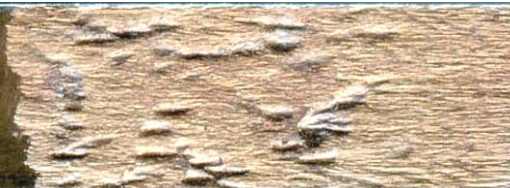
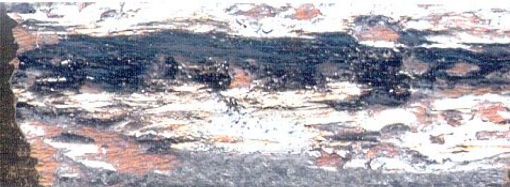
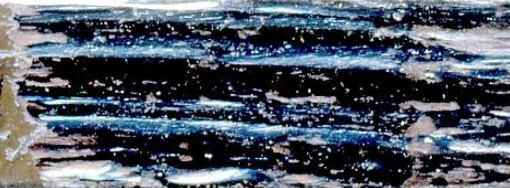
**Fig. 6:** Optical Images for Incoloy MA956 versus Incoloy 800HT at 0.314 m.s<sup>-1</sup>

<p><b>Room Temperature, 4,522 m – sample</b>  <i>(wear scar = 15 x 5 mm)</i>  Transfer layer covering 90% of wear scar</p>

<p><b>270°C, 4,522 m – sample</b>  <i>(wear scar = 17 x 5 mm)</i>  Transfer layer covering 80% of wear scar</p>

<p><b>510°C, 4,522 m – sample</b>  <i>(wear scar = 18 x 5 mm, also 390, 450, 570°C)</i>  Reduced transfer (10%), now in more isolated patches –  discoloration due to limited oxidation of wear surface</p>

<p><b>630°C, 4,522 m – sample</b>  <i>(wear scar = 20 x 5 mm)</i>  'glaze' covering large areas of highly worn wear scar, with  no evidence of metallic transfer</p>

<p><b>750°C, 4,522 m – sample</b>  <i>(wear scar = 19 x 5 mm, also 690°C)</i>  'glaze' covering most of wear scar, no evidence of metallic  transfer</p>

Optical and SEM examination (Figs. 6, 7, 8 and 9) indicated that at R.T. and 270°C, Incoloy MA956 sample wear surfaces were metallic and highly damaged (indicative of severe wear), with extensive metallic transfer onto the Incoloy MA956 surface at 0.314, 0.654 (not shown) and 0.905 m.s<sup>-1</sup>. The resulting metallic transfer layer covered almost the entire wear scar, coinciding with fairly low weight loss at these temperatures. Confirmation of which was transfer layer and which was exposed substrate (and thus level of coverage) was made by spot EDX analysis (Section 3.3.1), possible due to changes in composition from mechanical alloying.

Transfer levels at all three sliding speeds were much lower at temperatures of 390°C and above. The decreasing transfer was accompanied by increasing discolouration due to very limited oxidation of the exposed metallic surfaces (Figs. 6 and 7 – this oxidation, though sufficient to cause an increase in metallic discolouration, did not build up into wear-protective oxide layers), coinciding with increasing sample weight loss. At 0.314 m.s<sup>-1</sup>, only isolated areas of transferred metallic material were deposited on the wear scar surfaces covering at most ~5 to 10% of their area. Metallic transfer at 0.654 and 0.905 m.s<sup>-1</sup> was slightly higher, though the patchy metallic transfer layers formed were still limited to ~50% of the wear scar; this greater transfer may explain the apparent reduced weight change values at 0.905 m.s<sup>-1</sup> (compared to 0.314 m.s<sup>-1</sup>) seen between 390 and 630°C. There was no clear evidence of this oxide modifying or further enhancing wear by abrasion at any sliding speed (a highly damaged, metallic surface persisted with no apparent polishing effect), though some abrasive effect cannot be discounted.

‘Glaze’ formation and ‘mild wear’ at 0.314 was first observed at 630°C (Figs. 6 and 8), covering approximately 70% of the wear scar. The ‘glaze’ layers became more comprehensive with 90% wear scar coverage on increasing sliding temperature to 690°C and 750°C (Figs. 6 and 8); the arrest in increasing weight loss at 750°C was observed alongside this.

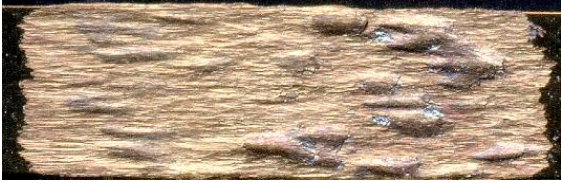
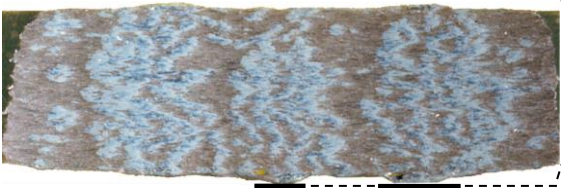
**Fig. 7:** Optical Images for Incoloy MA956 versus Incoloy 800HT at 0.905 m.s<sup>-1</sup> (similar results at 0.654 m.s<sup>-1</sup>)

<p><b>270°C, 4,522 m – sample</b>  <i>(wear scar = 15 x 5 mm)</i>  Transfer layer covering 75% of wear scar</p>

<p><b>510°C, 4,522 m – sample</b>  <i>(wear scar = 18 x 5 mm, also 390, 450, 570°C)</i>  Reduced metallic transfer with incomplete transfer layers (50%), though greater than at 0.314 m.s<sup>-1</sup> – increasing discoloration of wear surfaces due to limited oxidation</p>

<p><b>630°C, 4,522 m – sample</b>  <i>(wear scar = 19 x 5 mm)</i>  Isolated areas of 'glaze' on asperities (raised areas) of limited transferred material</p>

<p><b>750°C, 4,522 m – sample</b>  <i>(wear scar = 18 x 5 mm, also 690°C)</i>  Evidence of significant plastic deformation of the Incoloy MA956, 'glaze' build-up beginning to spread out from asperities</p>

At 0.654 and 0.905 m.s<sup>-1</sup>, ‘glaze’-type layers on the Incoloy MA956 samples first appeared at 630°C (Fig. 7 shows the 0.905 m.s<sup>-1</sup> example), but only in limited patches. Oxide layer formation increased with temperature and at 0.654 m.s<sup>-1</sup>, patchy ‘glaze’ layers were observed at 690°C; there was comprehensive ‘glaze’ coverage at 750°C, coinciding again with weight loss being arrested. However, oxide layer formation was suppressed at 0.905 m.s<sup>-1</sup> with still patchy ‘glaze’ formation at 690°C. There was no more than 40 to 50% ‘glaze’ coverage at 750°C (though sufficient to allow cross-sectional analysis – Figs. 7 to 9), with no accompanying arrest in weight loss.

At 690 and 750°C, there was evidence of material softening and plastic deformation of the Incoloy MA956, the clearest indication being 'rims' of material pushed out from the sides of the wear interface. These were most apparent at 750°C and 0.905 m.s<sup>-1</sup> (Fig. 7).

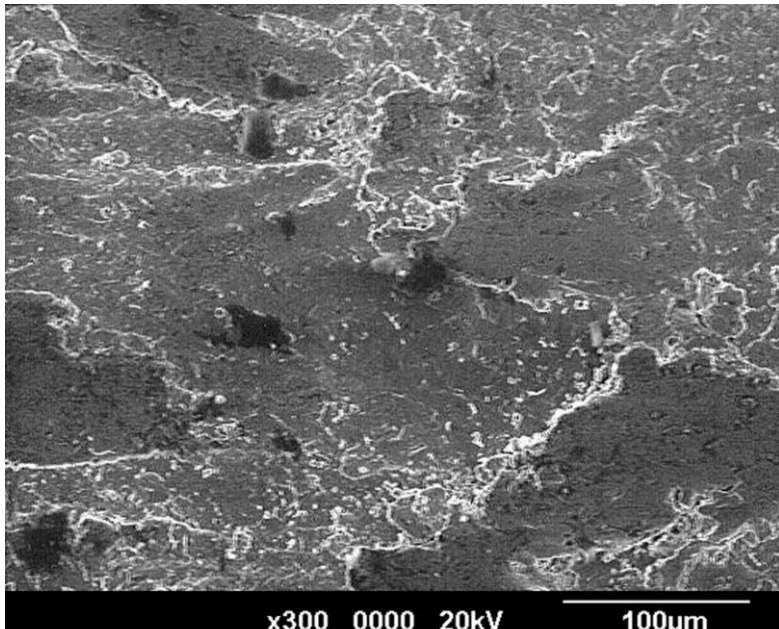
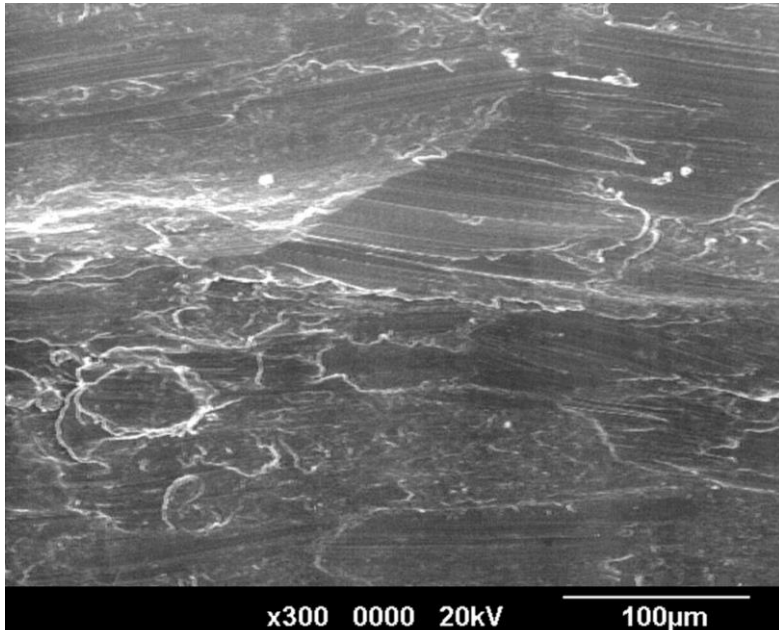
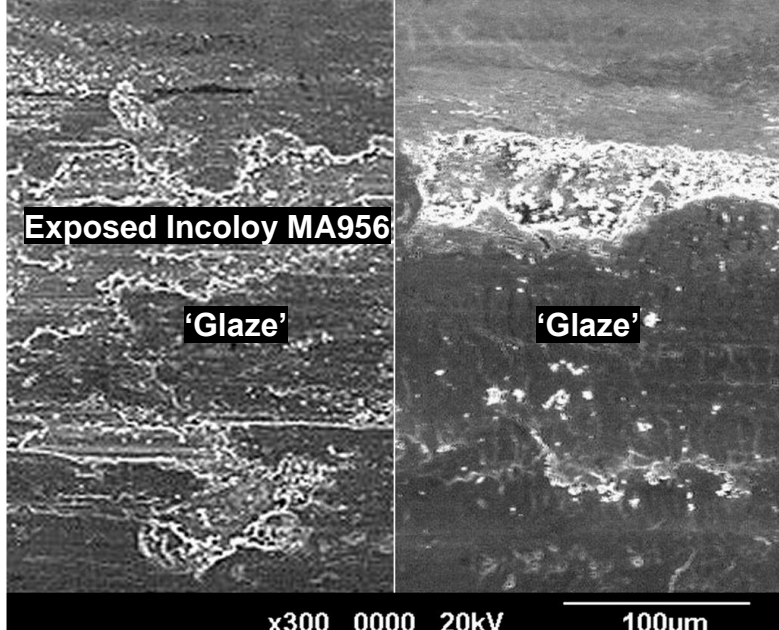
**Fig. 8:** SEM micrographs for Incoloy MA956 versus Incoloy 800HT at 0.314 m.s<sup>-1</sup> – wear surfaces

<p>x300 0000 20kV 100µm</p>	<p>A. Room Temperature (shown), also 270°C</p> <p>Mechanically mixed metallic transfer layers covering most of Incoloy MA956 wear scar</p>

<p>x300 0000 20kV 100µm</p>	<p>B. 510°C (shown), also 390, 450 and 570°C</p> <p>Deformed metal from 'severe wear' with patchy metallic transfer</p>

<p>Exposed Incoloy MA956</p> <p>'Glaze'</p> <p>'Glaze'</p> <p>x300 0000 20kV 100µm</p>	<p>C. 630 (left) and 750°C (right), also 690°C</p> <p>'Glaze' formation in early stages at 630°C, more developed 'glaze' at 690 (not shown) and comprehensive development at 750°C</p>

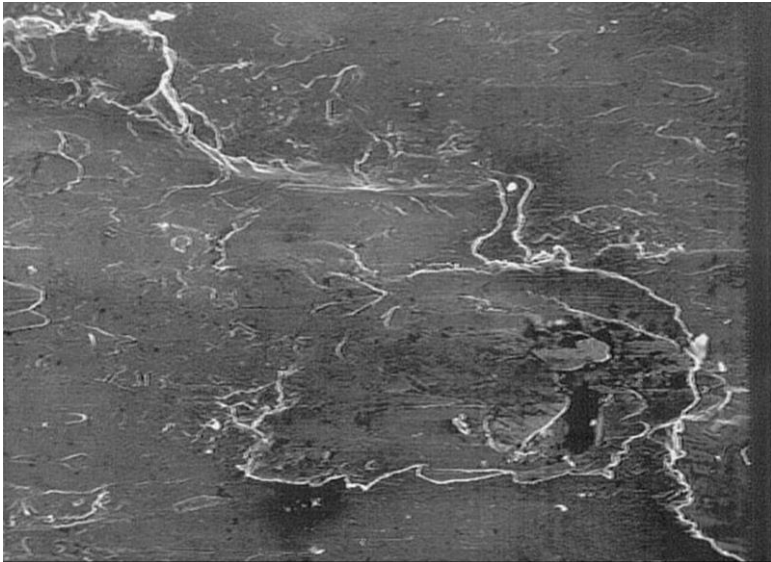
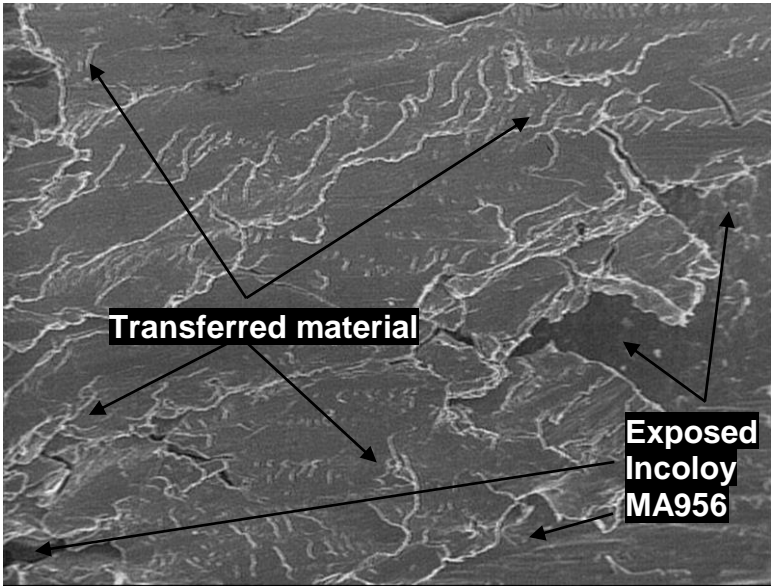
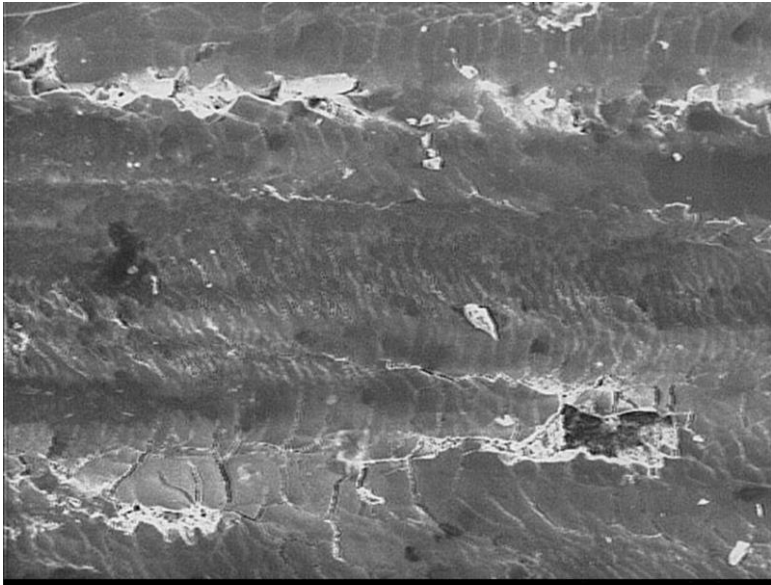
**Fig. 9:** SEM micrographs for Incoloy MA956 versus Incoloy 800HT at 0.905 m.s<sup>-1</sup> – wear surfaces

<p data-bbox="384 663 831 696">x300 0000 20kV 100µm</p>	<p data-bbox="948 315 1442 383">A. Room Temperature (shown), also 270°C</p> <p data-bbox="995 398 1410 499">Mechanically mixed metallic transfer layers covering most of Incoloy MA956 wear scar</p>

<p data-bbox="384 1328 831 1361">x300 0000 20kV 100µm</p>	<p data-bbox="948 943 1394 1010">B. 510°C (shown), also 390, 450, 570 and 630°C</p> <p data-bbox="995 1025 1442 1160">Deformed metal from 'severe wear' with limited metallic transfer (greater than at 0.314 m.s<sup>-1</sup>), odd patch of 'glaze' at 630°C only</p>

<p data-bbox="384 1993 831 2027">x300 0000 20kV 100µm</p>	<p data-bbox="948 1581 1358 1615">C. 750°C (shown), also 690°C</p> <p data-bbox="995 1630 1426 1798">'Glaze' formation very patchy at 690°C (not shown), more developed 'glaze' but still patchy at 750°C and more fractured at 0.905 m.s<sup>-1</sup> than at 0.314 m.s<sup>-1</sup></p>

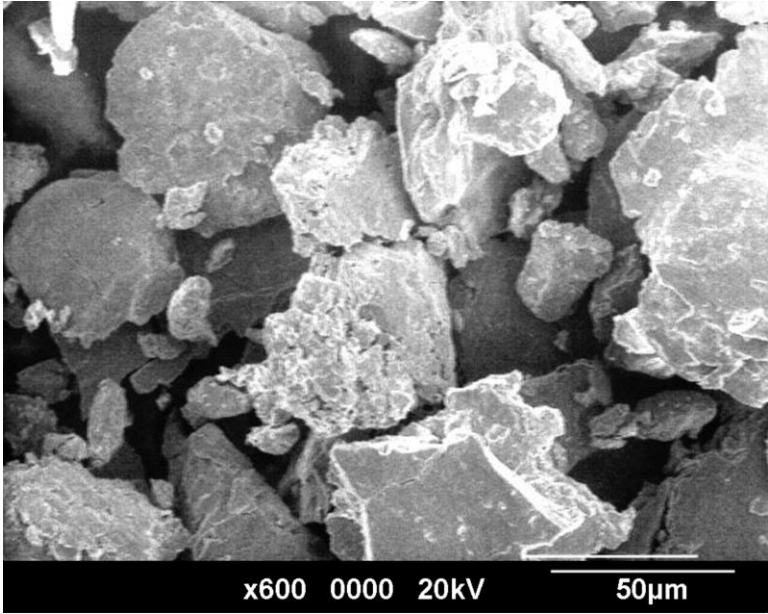
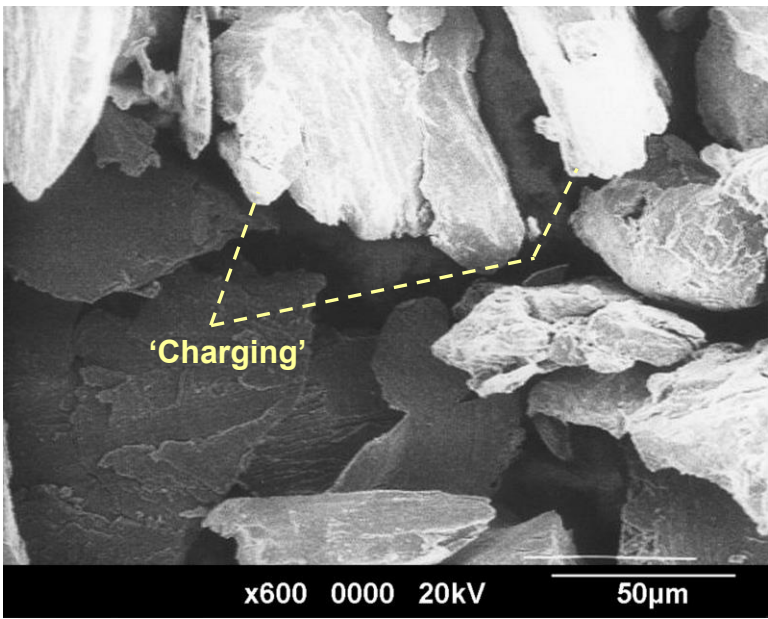
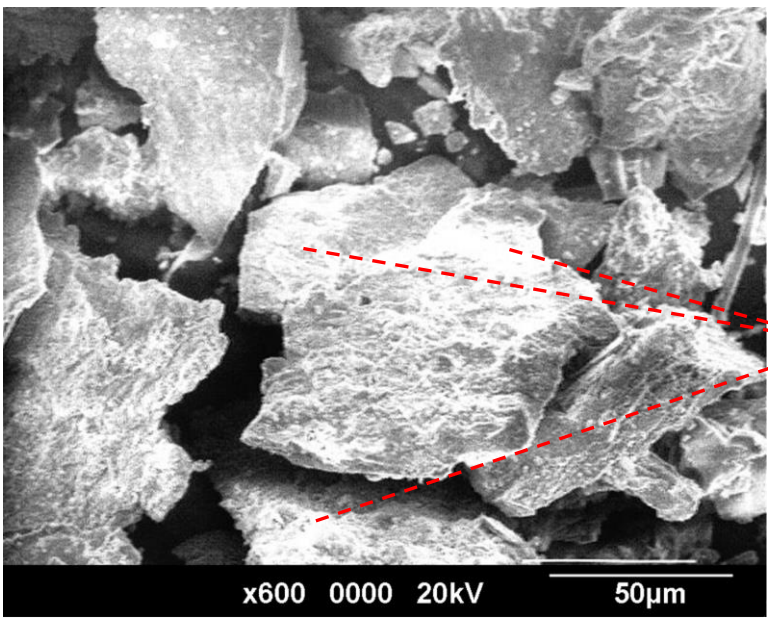
**Fig. 11:** SEM micrographs for Incoloy MA956 versus Incoloy 800HT at 0.314 m.s<sup>-1</sup> – debris

<p>A. Room Temperature (shown), also 270°C</p> <p>Large, flat angular metallic particles of size between 20 <math>\mu\text{m}</math> and 1 mm</p>

<p>B. 510°C (shown), also 390, 450 and 570°C</p> <p>Large, flat angular metallic particles of size between 20 <math>\mu\text{m}</math> and 1 mm</p> <p>Very fine oxide debris (&lt;1 <math>\mu\text{m}</math> in size) present in very low amounts from 390°C and increasing with rising temperature.</p> <p>'Charging' on debris due to the presence of oxide at 510°C</p>

<p>C. 630 and 750°C (shown), also 690°C</p> <p>Large, flat angular metallic particles of size between 20 <math>\mu\text{m}</math> and 1 mm</p> <p>Very fine oxide debris (&lt;1 <math>\mu\text{m}</math> in size) present in significant amounts from 630°C upwards</p>

The large flat platelet-type metallic debris particles typical of delamination wear (Figs. 11 and 12), were produced at all three sliding speeds over the entire range of test temperatures (R.T. to 750°C); particle sizes ranged between 20 µm and 1 mm. No oxide was present amongst this metallic debris at R.T. and 270°C. At 390°C, 450°C, 510°C and 570°C, some oxide debris was observed, but only in trace amounts amongst the overwhelmingly metallic debris; this coincided with the discolouration of wear scar surfaces due to very limited oxidation at these temperatures. Further evidence of limited oxidation (insufficient to form oxide layers) was hinted at during SEM by charging on the metallic debris surfaces at 510°C (Fig. 11) and 0.314 m.s<sup>-1</sup> during SEM.

At R.T. and 270°C (Fig. 16, Region 1), moderate amounts of flattened metallic wear debris (Figs. 11 and 12) were produced by a standard ‘severe wear’ delamination-type mechanism from both the Incoloy MA956 sample and Incoloy 800HT counterface. Much of this metallic debris readhered to either the sample or counterface, forming a mechanically mixed metallic transfer layer (Figs. 6 to 9), which became work hardened due to sliding (Table 3) and limited the amount of wear (Fig. 2). The mechanical mixing producing this layer was incomplete (i.e. heterogeneous), demonstrated by variable levels of Ni, Cr and Fe and the reduced Ni-containing  $\text{Cr}_{0.19}\text{Fe}_{0.7}\text{Ni}_{0.11}$  phase detected during XRD. The absence of oxide from either sliding surface at R.T. and 270°C indicated oxidation played no significant part in the wear process, either to protect the wear surfaces from high wear (as was the case with Incoloy MA956 versus Stellite 6 [6]) or to inhibit adhesion and transfer layer build-up on either surface.

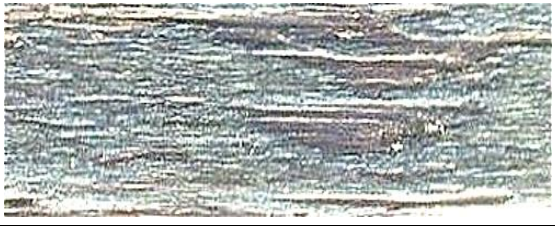
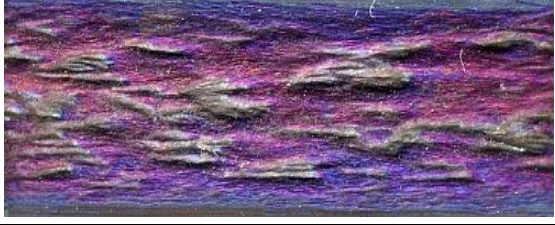
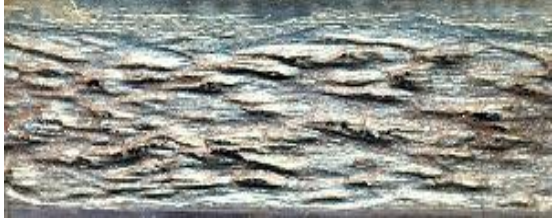
<p><b>Room Temperature, 4,522 m – counterface</b>  <i>(section = 15 x 5 mm, representative up to 450°C)</i>          Highly worn wear scar with limited transfer layer</p>

<p><b>570°C, 4,522 m – counterface</b>  <i>(section = 15 x 5 mm, applicable between 510°C and 630°C)</i>          Deeply grooved wear scar, 'glaze' free asperities formed due to transfer and / or back-transfer of metallic debris</p>

<p><b>750°C, 4,522 m – counterface</b>  <i>(section = 15 x 5 mm, also applicable at 690°C)</i>          Deeply grooved wear scar, 'glaze' forming only on tops of transferred / back-transferred asperities with slightly fewer asperities at 0.905 m.s<sup>-1</sup></p>

(a) Counterface wear scar optical images

(b) Counterface wear scar cross-section schematic

Severe wear of the Incoloy 800HT counterface was observed at 0.314, 0.654 and 0.905 m.s<sup>-1</sup> throughout the range of test temperatures, with observations almost identical regardless of sliding speed (Fig. 13a shows examples from 0.314 m.s<sup>-1</sup>). Between R.T. and 450°C, the counterface wear scar was highly worn with a limited metallic transfer layer forming upon it, due to transfer and back-transfer between the Incoloy MA956 sample and the counterface. A reduction in this layer was observed at 390°C and 450°C (mirroring sample behaviour), coinciding with wear surface discoloration due to limited oxidation.

At 510°C and above, the Incoloy 800HT counterface wear track formed a deep, heavily worn 1.5 mm deep groove (Fig. 13b) and from 570°C upwards, asperities appeared within this wear track (slightly fewer at 0.905 m.s<sup>-1</sup>). The asperities reached heights of up to 1.5 mm above the unworn

counterface and can only have been formed from redeposition of removed material. 'Glaze' formed at 690 and 750°C at all three sliding speeds, but only on asperity peaks; this matched the increased oxide layer formation on the Incoloy MA956 wear surfaces at these temperatures. This 'glaze' can only have formed after the asperities, indicating early counterface 'severe wear' before 'mild wear' was established.

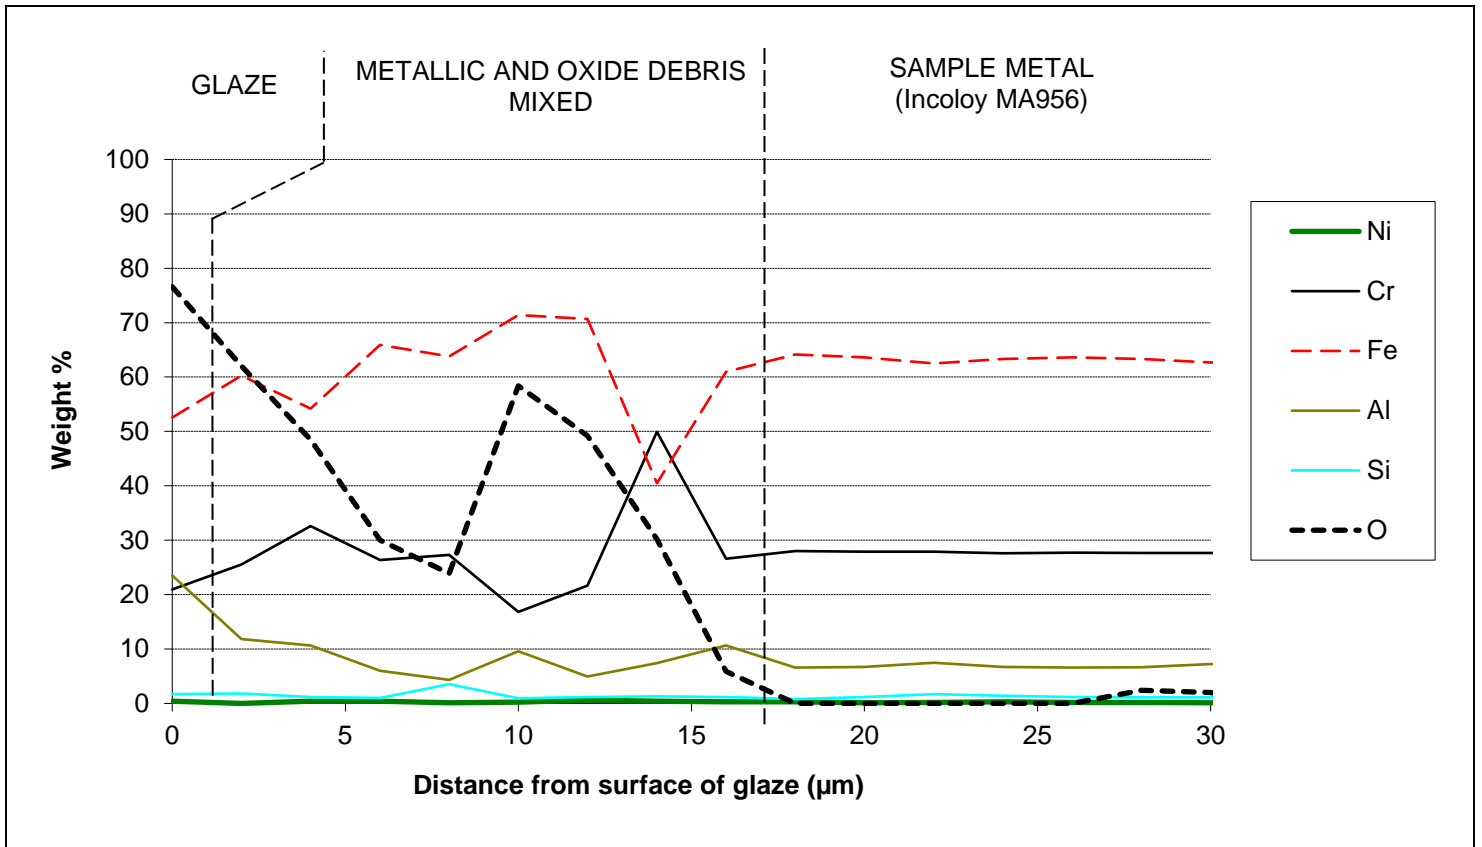
(a) Autopoint EDX

(b) Cross-section

A two-layer structure was observed on all 0.314 m.s<sup>-1</sup> samples examined (Fig. 14), consisting of a 'glaze' layer of no more than 2 µm thickness and a mixed metal-oxide layer, extending usually to between 15 to 20 µm depth (17 to 18 µm in the discussed example). However, localised reduced removal from the Incoloy MA956 sample material during early severe wear has led to the intermediate mixed metal-oxide layer deposited following being much thinner in some locations; Fig.13 demonstrates one such area where the mixed metal-oxide layer is only 3 to 4 µm thick. Incoloy 800HT-sourced Ni levels were negligible (~0.3%) in the 'glaze' and debris layers; the Incoloy MA956 was thus the near-exclusive source for the 'glaze' and mixed metal-oxide debris, which consisted of Fe, Cr, Al and trace Si (~1.4% max.).
