Kenwood TS-830

Survival Guide

Kenwood TS-830 Survival Guide, ed. [Olaf Rettkowski](#), DL9AI, ver.1.2, 03 Dec 2002,
rev. 21 Dec 2008

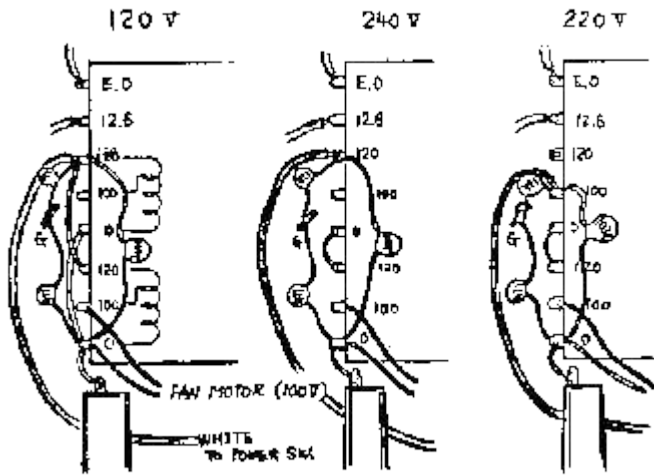
1. Unplug the AC power cable.
 2. Remove the bottom cover.
 3. Remove the jumper wires between the two \emptyset terminals and two 120 terminals on the bottom of the power transformer.
 4. Connect the adjacent 120 and \emptyset terminals at the middle of the transformer. This will provide 240 V AC operation.
- For 220 V AC operation, connect the adjacent 100 to \emptyset winding.
5. Change the AC fuse from 6 A to 4 A. Tag the power cord at the back of the radio to indicate that the transformer is strapped for 240 V AC, and the power fuse should be 4 A, and not 6 A.
 6. Replace the bottom cover and reconnect power to verify your work.
